Docket No. 217 – Development and Management Plan Inspection

Northeast Utilities Service Company Certificate of Environmental Compatibility and Public Need for the construction of a 345-kV electric transmission line and reconstruction of an existing 115-kV electric transmission line between Connecticut Light and Power Company's Plumtree Substation in Bethel, through the towns of Redding, Weston, and Wilton, and to the Norwalk Substation in Norwalk, Connecticut.

Date: February 2, 2006

Location: 115 kV Underground Route

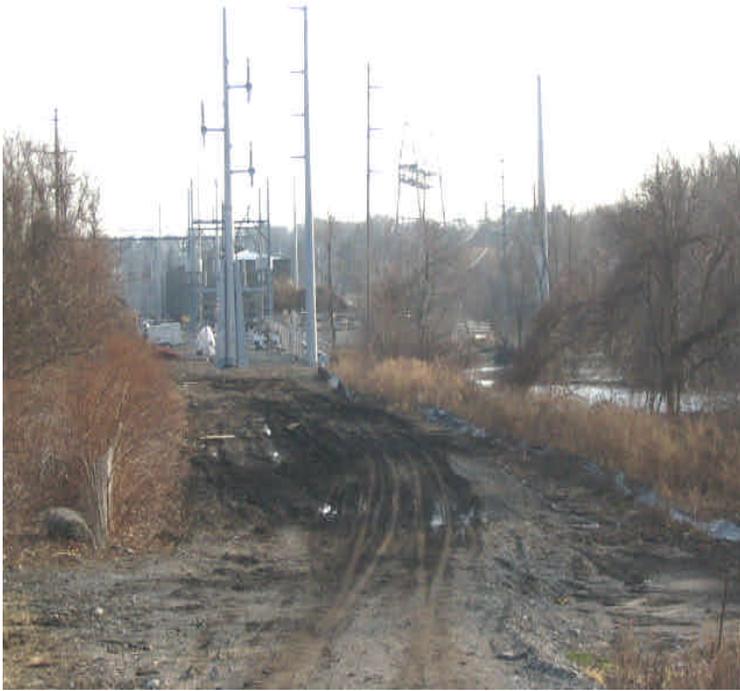
115kV (ROW and Putnam Park): Photo on the left shows a view of the ROW adjacent to the Norwalk substation where the bike path will be constructed in the spring. Photo on the right shows a view of the Putnam Park storage area where erosion controls remain well in place. 2/2/06

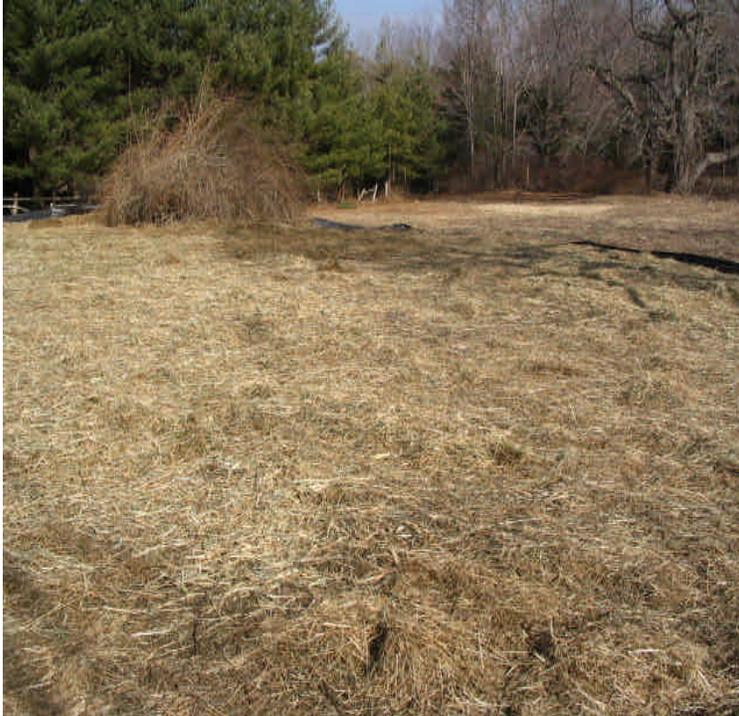
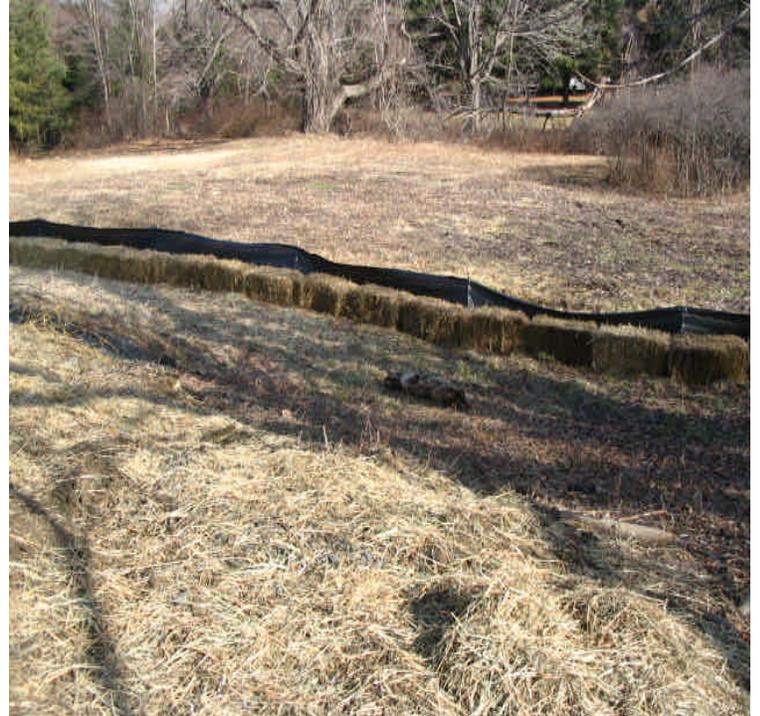
115kV (Rt. 107): Photo shows the "Rt. 107 turn" storage area where the entire yard has been mulched with hay and erosion controls remain well in place. 2/2/06

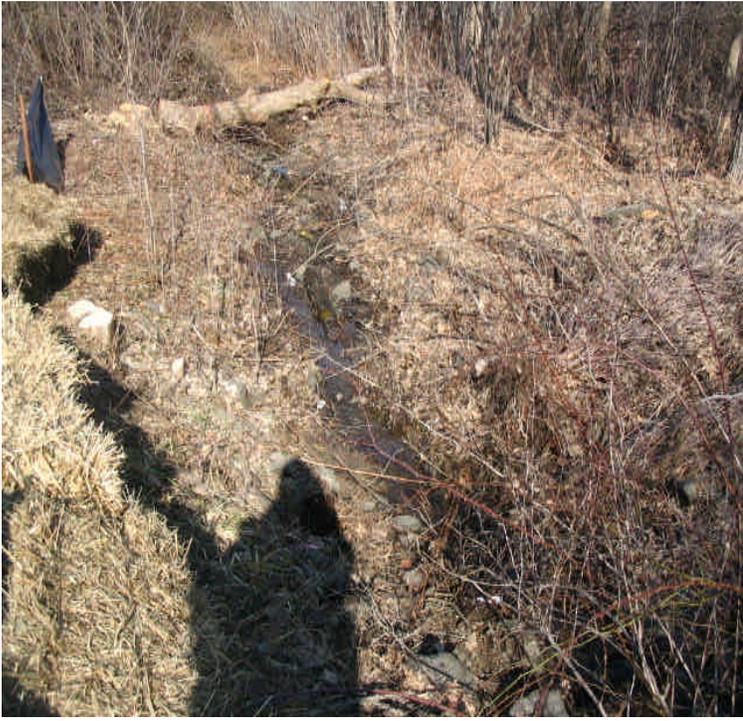
115kV (Rt.58). Photos shows a view of the Sunset Hill Rd. storage area. Photo on the left shows the wet swale where accumulated sediment was removed. Photo on the right shows a view of the yard which has been mulched with hay and erosion controls are well in place. 2/2/06

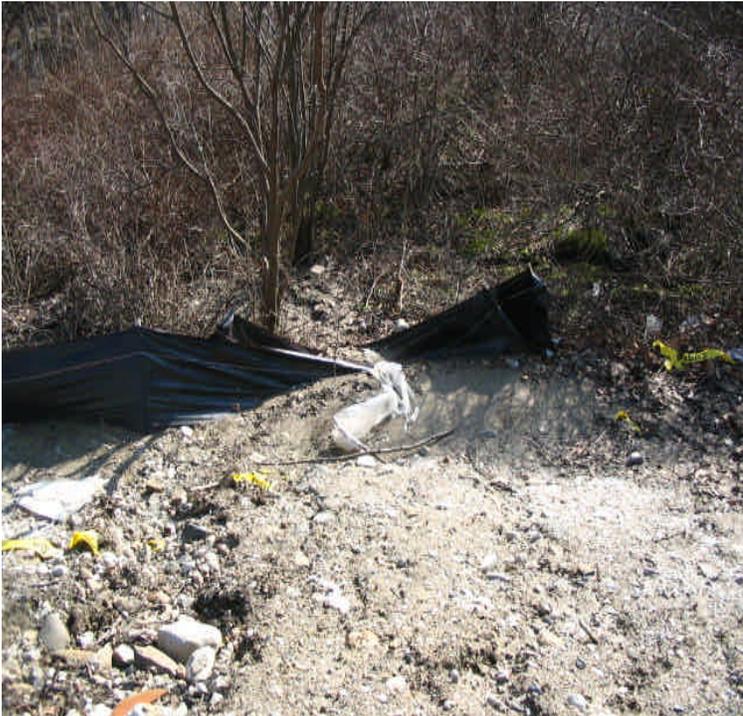
Areas of Inspection	Observation	Recommended Action
<p>Erosion and Sediment Controls (includes inspection within 24 hours of a storm event)</p> <p>Bethel Educational Park</p>	<p>- The gully along the northern ROW continues to washout, leaving a trail of sediment into the woods. 12/8-2/2/06</p> <p>-Several washouts along the southern ROW were worsening with sediment over the silt fence at the slope near the tower and a large gully along the access road. 1/26-2/2/06</p>	<p>-This gully has been placed with stone several times but continues to washout. Try larger stone or develop alternative solutions. 1/26-2/2/06</p> <p>- Repair the washouts and determine solutions for stabilizing the slope by the tower. 1/26/06</p>
<p>Hoyts Hill Riser Transition Structure (Off Rt. 58)</p>	<p>- Equipment access had created additional ruts along the sides of the drive in the mud. 11/23-2/2/06</p> <p>-Litter and materials left behind from the scaffolding were present.</p>	<p>-Check status in the spring. Provide repair and straw mulch/seed if necessary. 2/2/06</p> <p>- Provide good housekeeping. 1/26-2/2/06</p>

115kV (Bethel Ed) Photo on the left shows an area on the slope near the south tower where sediment washed out over the fence. Photo on the right shows a gully and washout along the ROW to the south tower. These areas should be repaired sooner than later. 2/2/06
